# Customer Story

In-situ Ceramic Lining at  
Cement plant

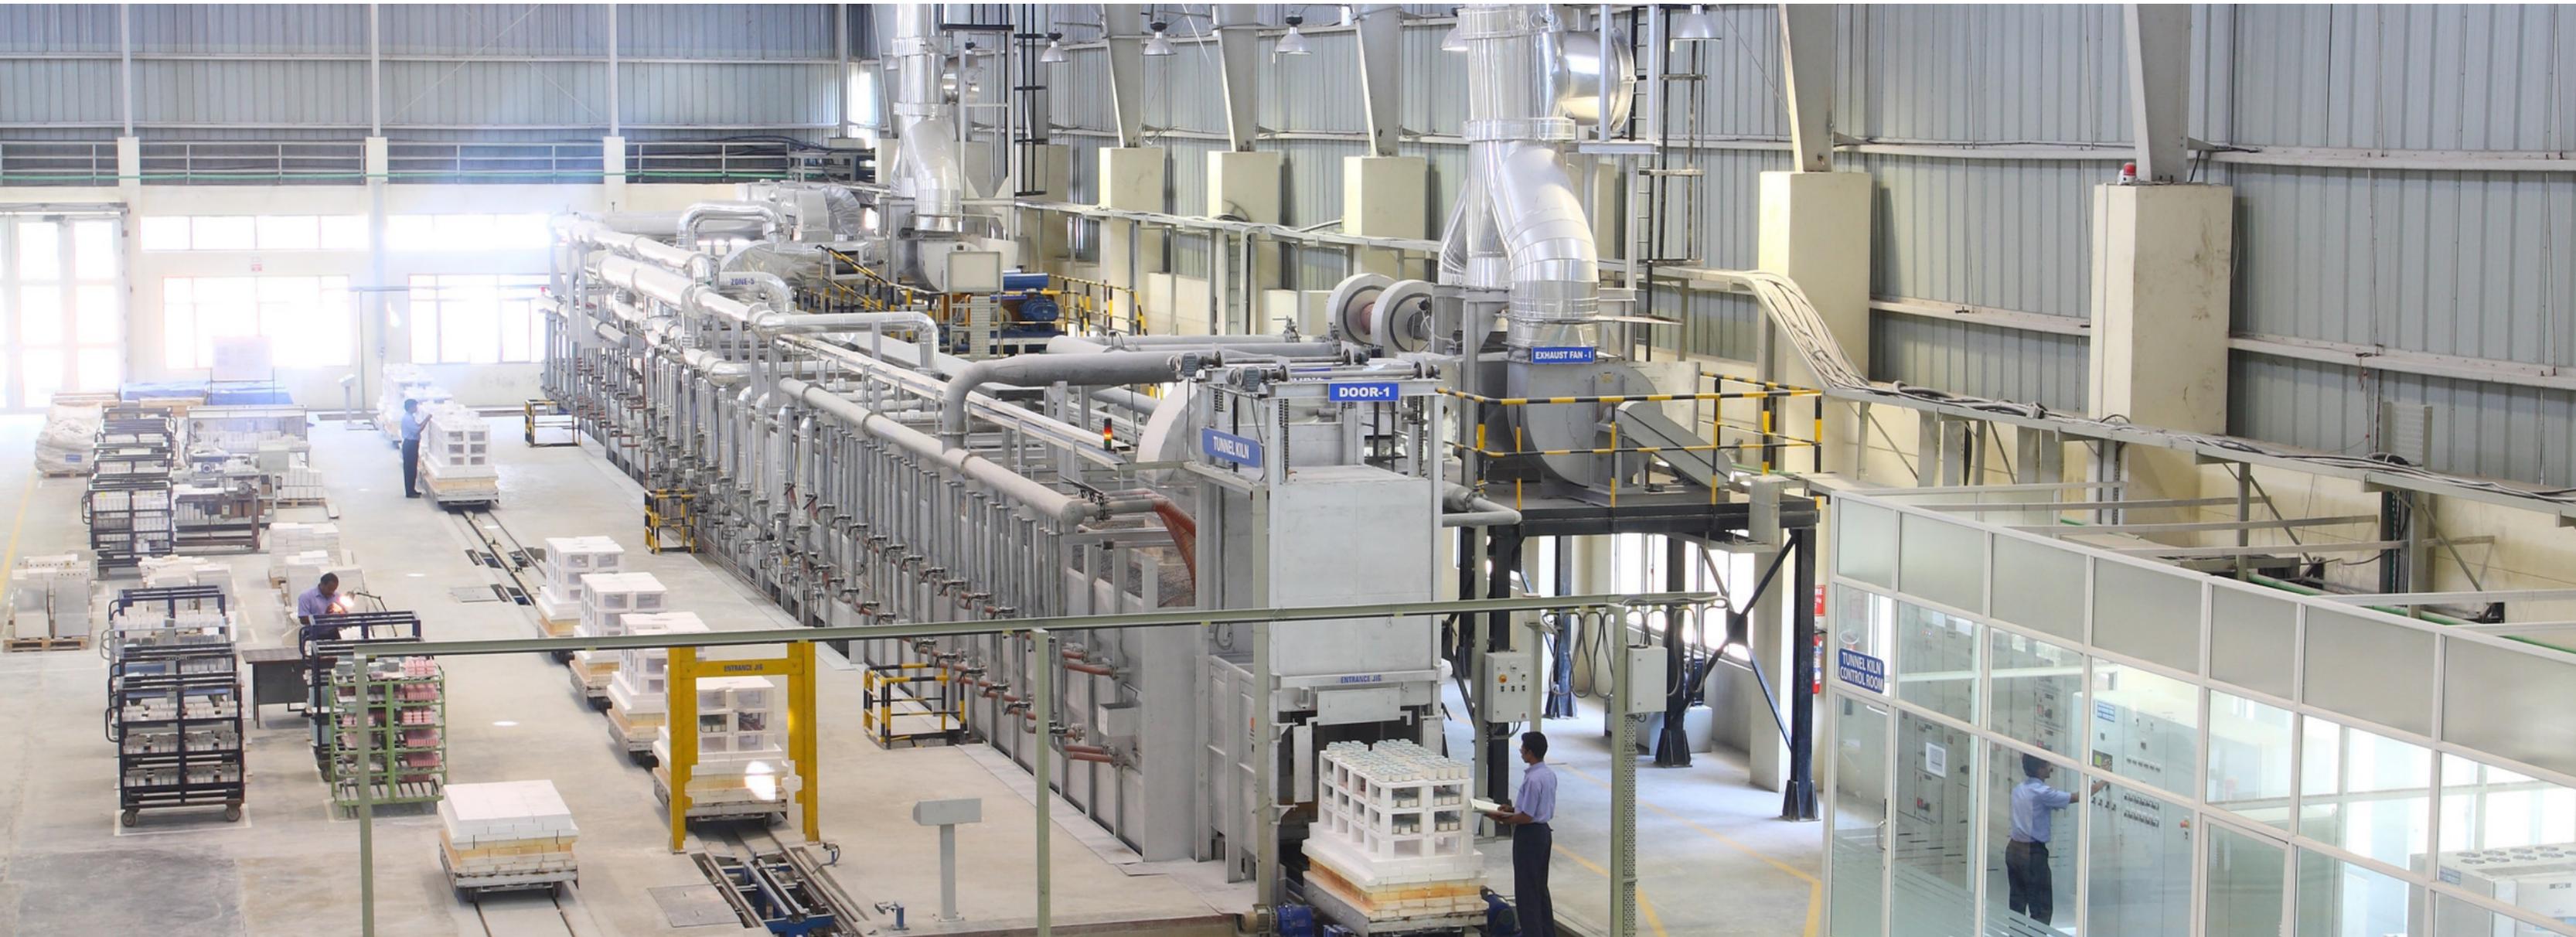
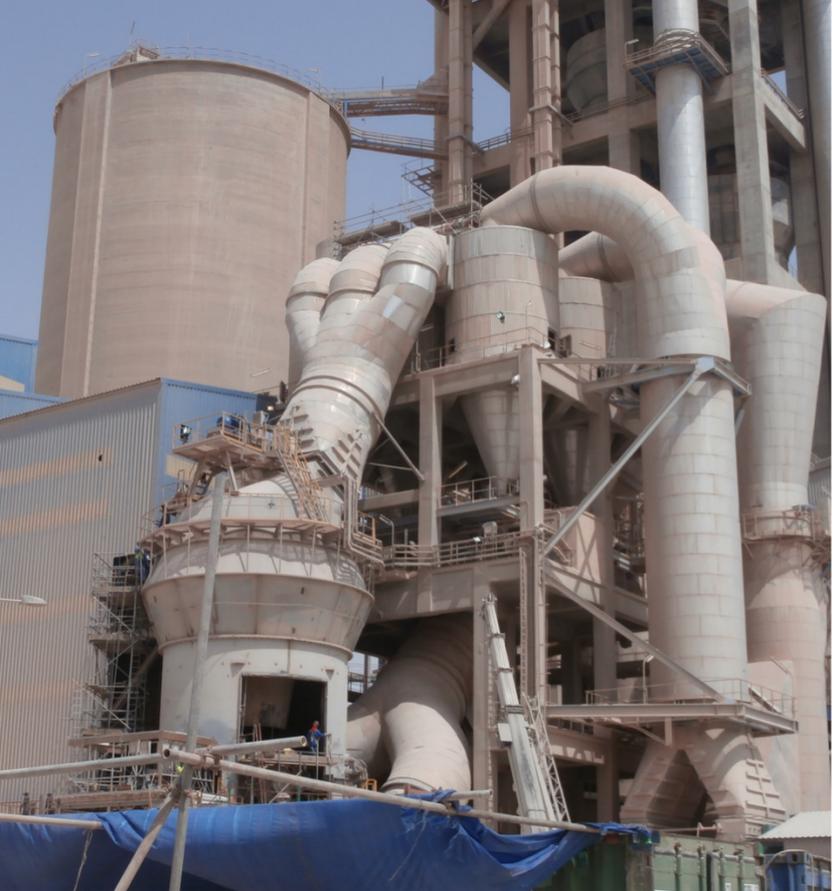
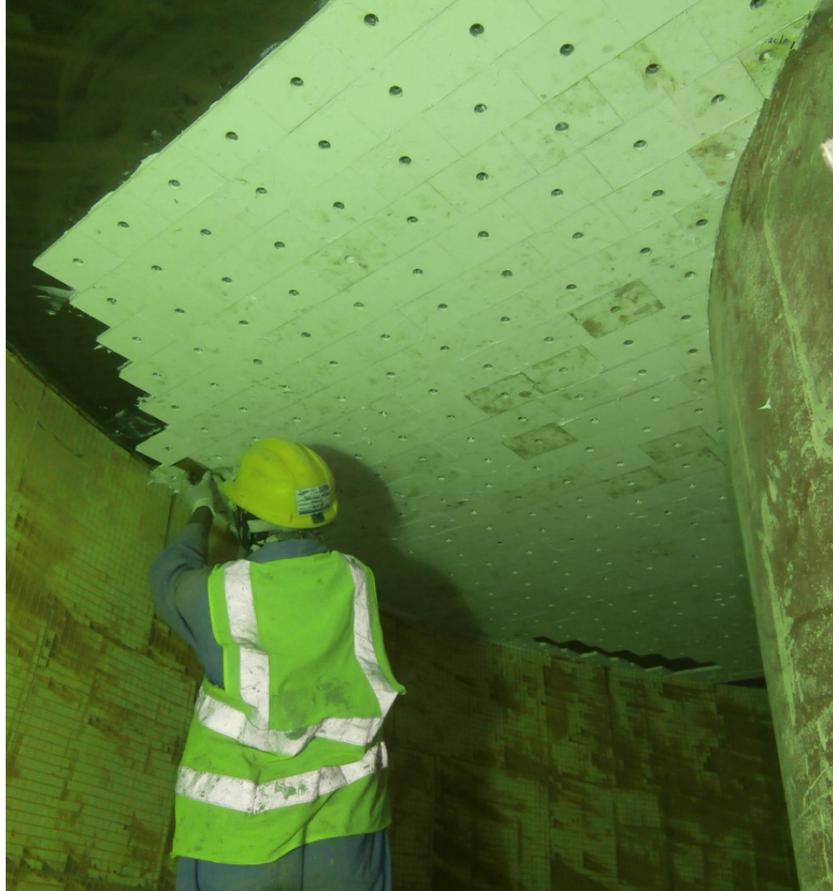
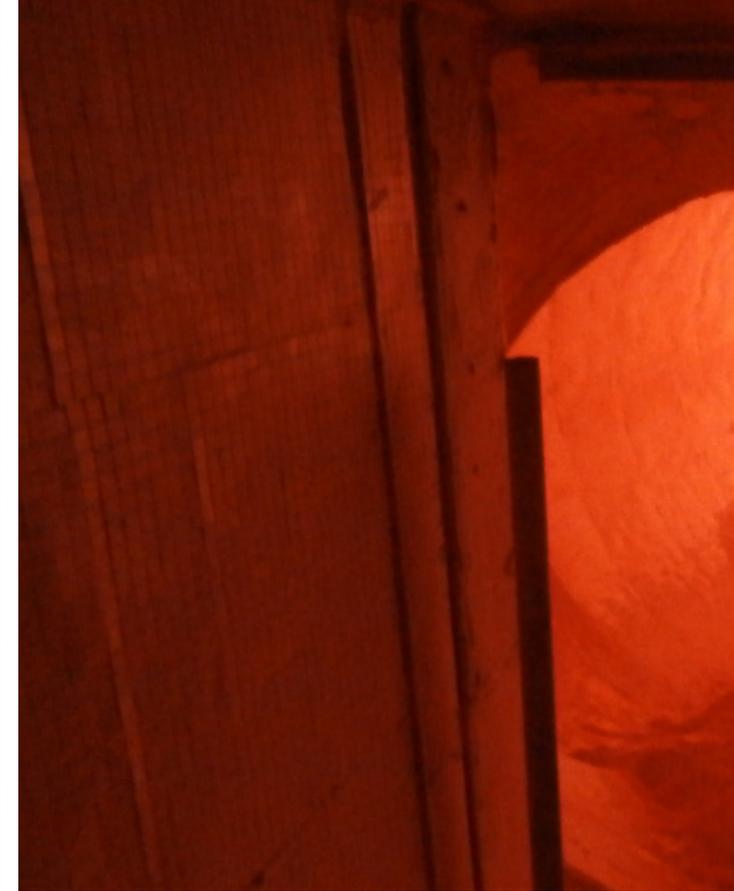
One of our biggest customer in Qatar was facing a situation where every year they had to undergo a patch up and repair work for their transport mediums which were getting eroded due to abrasive material transportation. These transport mediums were made up of steel without any preventive lining on the inner surfaces.

It was a **5000 Tonnes per day** capacity plant with a single unit which clearly meant that there was no margin for error and delay. The whole operation of ceramic lining covering a total area of **900 square meters** had to be done just within **15 days** during a maintenance shutdown. There were umpteen intricate shapes at abstruse locations which involved in-situ lining at several regions.

It was a total turnkey project where wear phenomenon and wear characteristics were studied at the site, complete wear resistant solution involving different wear resistances for different regions was designed, and finally, onsite installation was completed. Our customised wear resistant product, **CUMITUFF 92 High alumina** ceramic liners of **6mm thickness** was used for lining.

The ceramic lining application resulted in a progressive shift for our customer from breakdown maintenance to preventive maintenance. The **reliability factor** signifying the equipment life increased **from 83% to 96%** which in turn was also reflected by significant improvement in the yield levels. The ceramic lining application was done in 2013 and more than **80%** of the original ceramic thickness is still available for use. This is in sheer contrast to the earlier situation with bare steel which was getting eroded every year and thus leaking materials and ultimately leaking profits.
