Customer Story

Efficiency improvement for air
pre-heaters

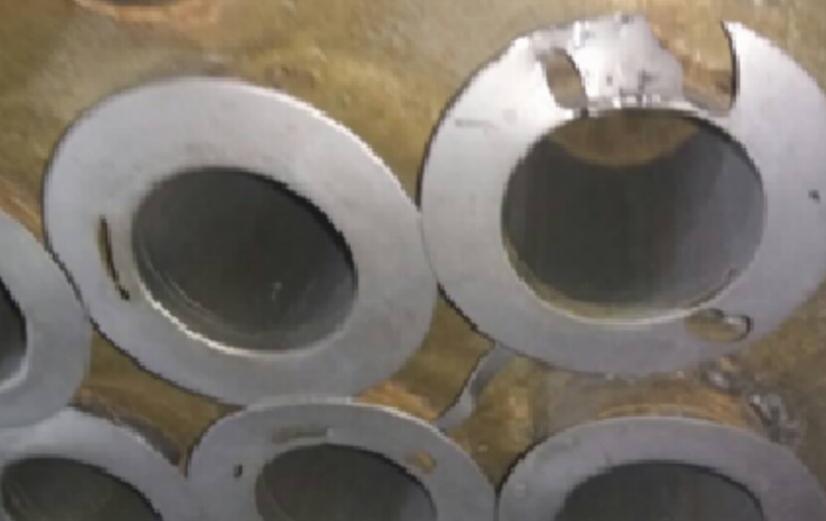
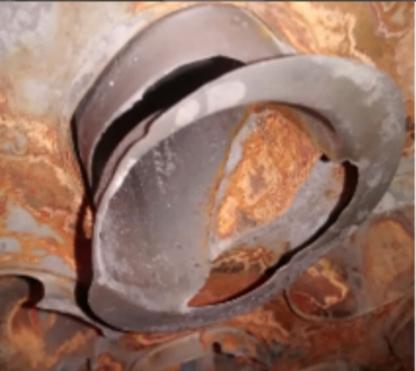
Metallic Ferrules worn-out badly exposing tube sheet welds & tube

The [wear phenomenon](#) and [wear characteristics](#) were studied at the customer site to understand the exact nature and extent of wear. Metallic ferrules were replaced by specifically engineered [ceramic ferrules](#) having [excellent wear resistance in high temperature environment](#).

Our customised wear resistant material, [CUMITUFF 92](#) High alumina ceramic was used for making ceramic ferrules.

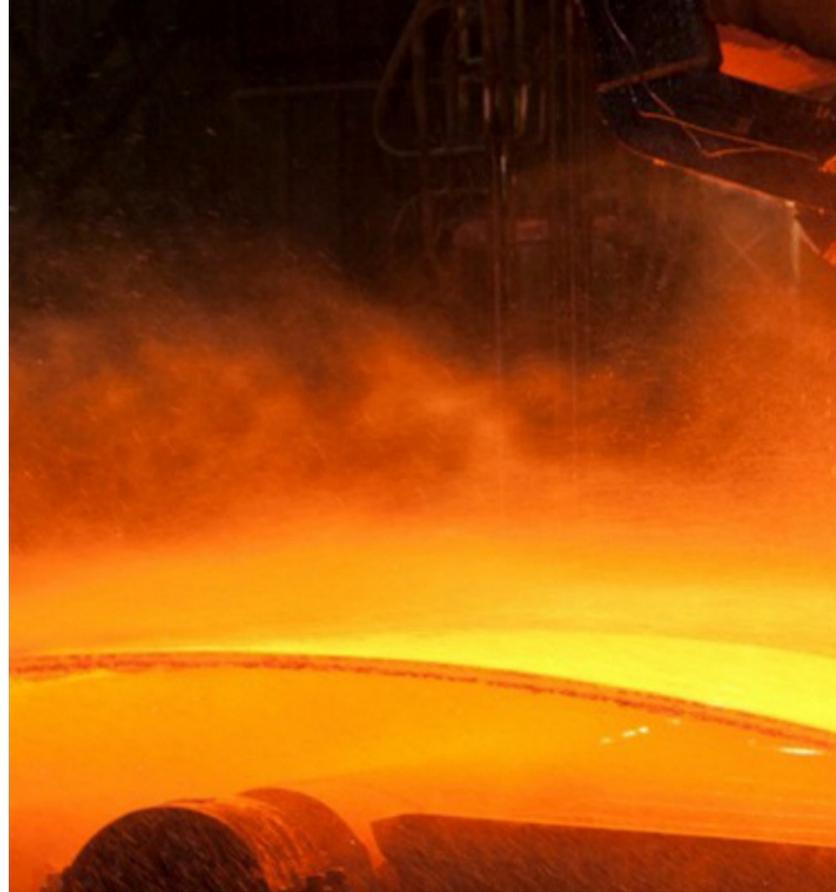
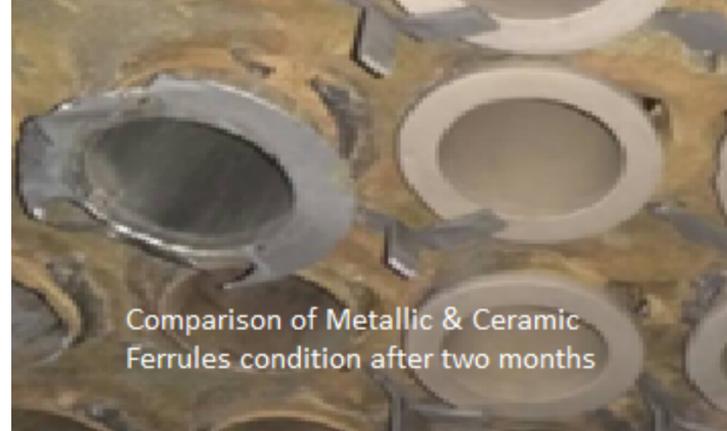
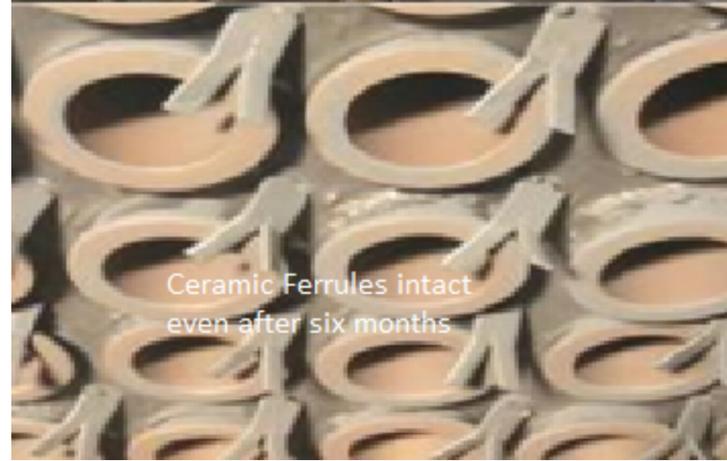
~06
times higher
lifespan than
existing metal
alternative

The [Ceramic Ferrules](#) ensured the protection of APH tube and it remained intact even after Six months of continuous operation assuring a [minimum one year safe working lifespan](#). This is in contrast to the [metallic ferrules](#), which used to get completely [punctured within two months](#).
